Proposed Upgrade of Sewerage Infrastructure in Woodlands, Eastern Cape.

Aquatic Biodiversity Impact Assessment

Prepared For: Blue Pebble (Pty) Ltd
Author: Jackie Dabrowski (PhD)
Confluent Environmental Pty (Ltd)
7 St. Johns Street,
Dormehls Drift,
George, 6529
Report Ref: CENV10
SACNASP: Pr. Sci. Nat. (Aquatic & Ecological
Science – 115166)
Date: July 2025
Version: Draft

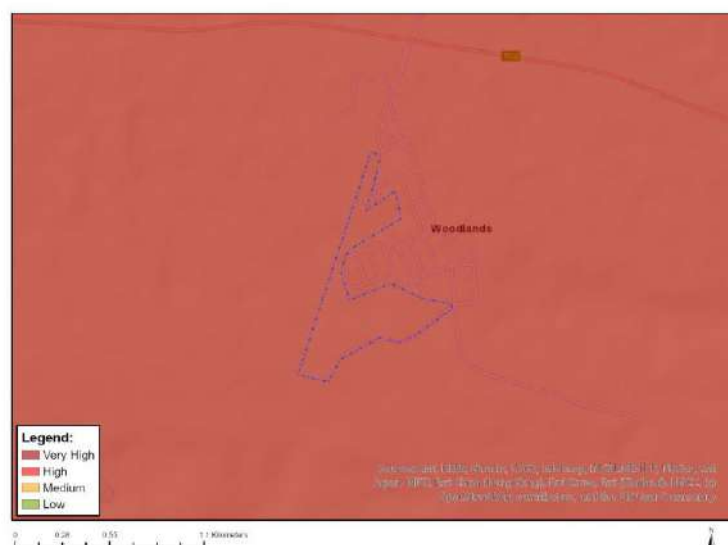
Figure 2: Results of the DFFE Screening Tool which indicate Very High Sensitivity of the Aquatic Biodiversity theme for the preferred development pipeline.

According to the Department of Forestry, Fisheries and Environment (DFFE) Screening Tool, the area in which the WWTW upgrade is proposed has a 'Very High' aquatic biodiversity sensitivity (Figure 2).

According to the DFFE screening tool, aquatic biodiversity at the site has a **Very High** sensitivity (Figure 2). The sensitivity features that triggered this classification are:

- Ecological Support Area 1 (ESA 1)
- Strategic Water Source Area (SWSA) for surface water in the Tsitsikamma

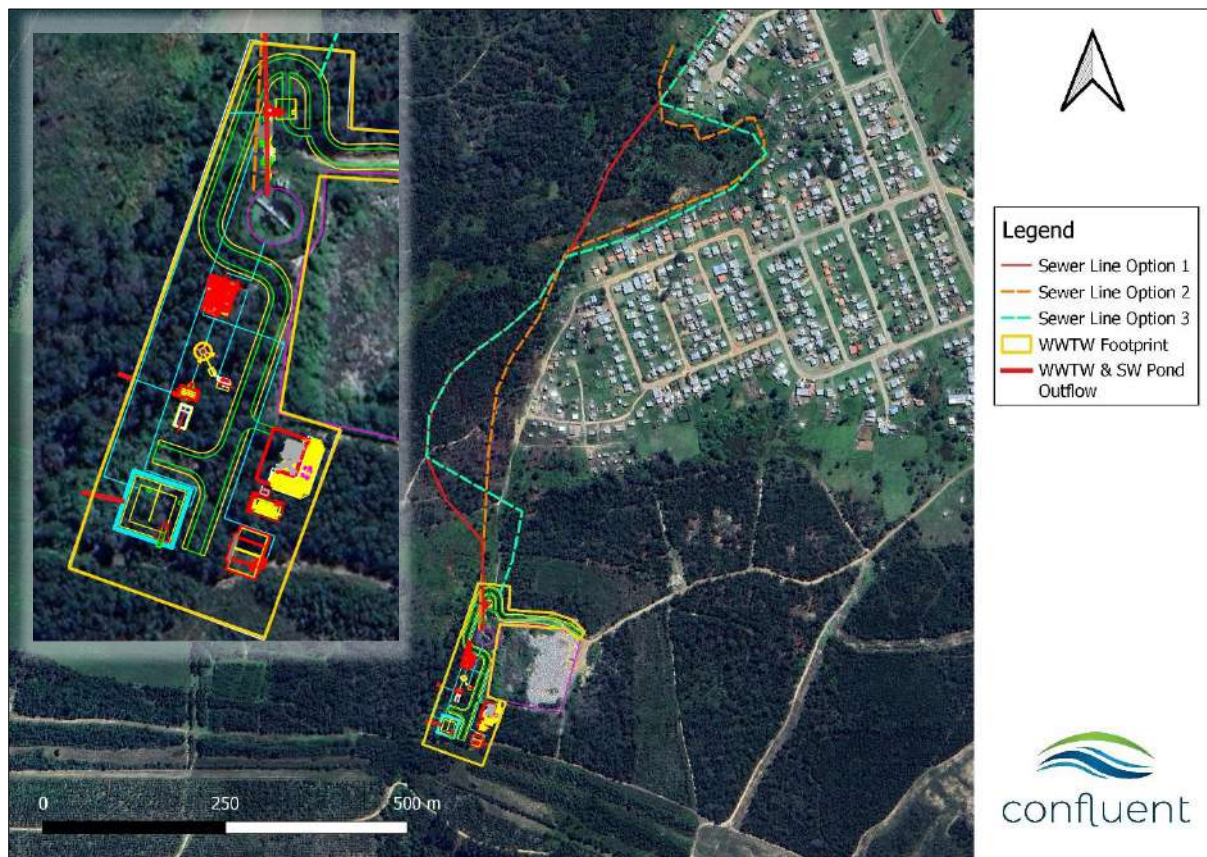
While specific engineering designs are still being finalised, the upgrade is expected to include the expansion of treatment units, improved sludge handling processes, and potentially the incorporation of energy-efficient and environmentally friendly technologies,

with the preferred option being option two (Rotating Biological Contactors) in the engineering report from SMEC South Africa Pty Ltd.

Figure 3. Map showing the progression of sewer line layout options and the proposed WWTW upgrade site at Woodlands (SMEC Engineering). Inset indicates enlargement of the WWTW.

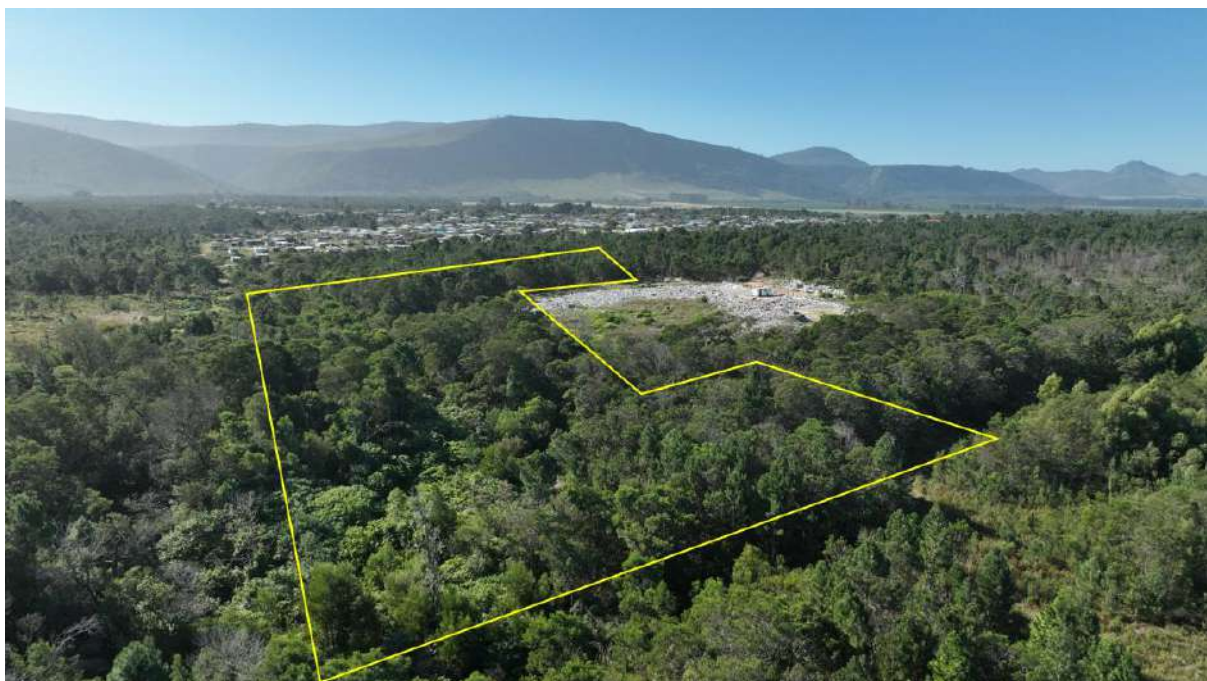
Figure 4. Approximate area of the new WWTW footprint adjacent to the existing landfill site in Woodlands.

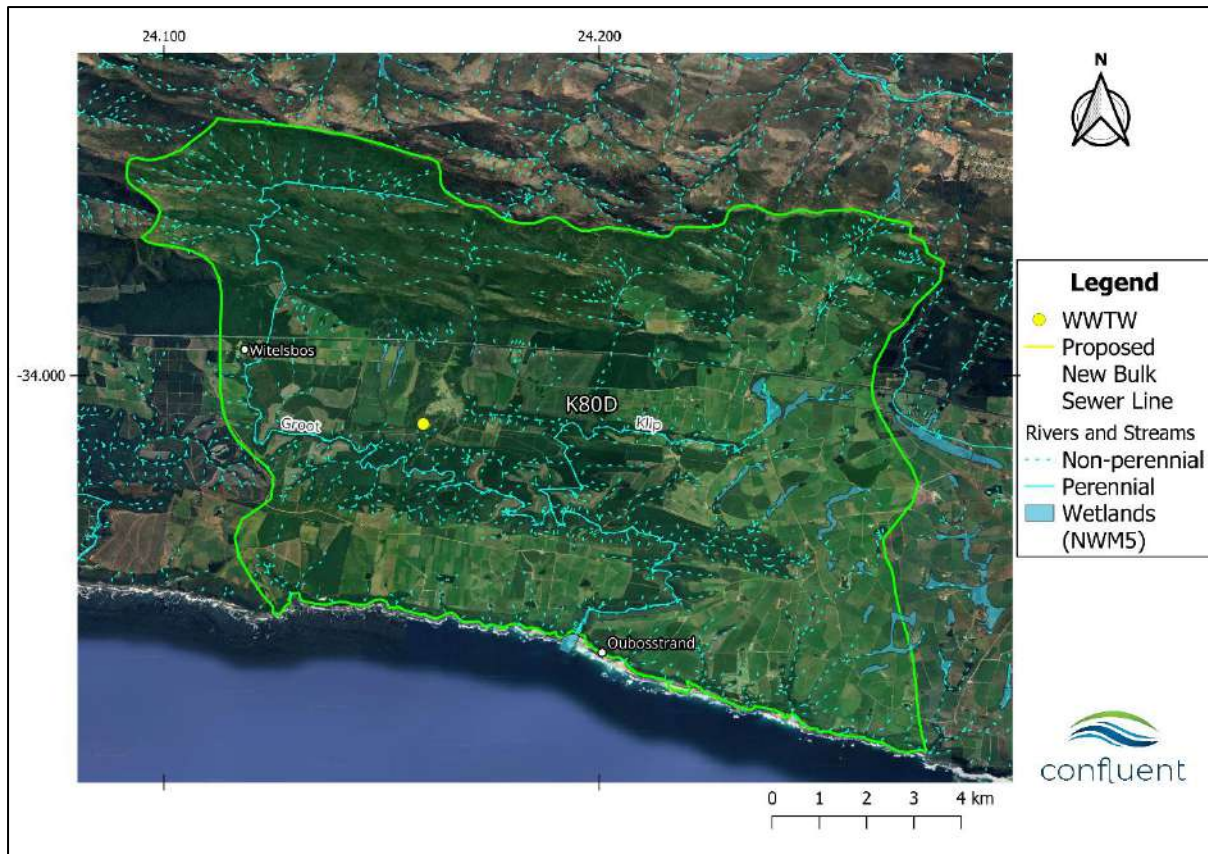
Figure 5. Location of the WWTW and proposed new bulk sewer line in the quaternary catchment K80D.

The proposed upgrade of the WWTW and associated infrastructure is in the quaternary catchment K80D (Figure 5). Five non-perennial rivers are mapped within 50 to 300 m around the proposed upgrade area, 2 flowing in a southern direction and 3 in an eastern direction. The area receives a substantial amount of rainfall on average, and as the rainfall intensity in the area is classified as Very High and the inherent erosion potential of soils also as Very High, erosion of soils and stormwater management are factors that must be carefully considered during the upgrade of the WWTW and the associated sewer infrastructure, especially considering the large amounts of stormwater runoff that associated with increasing urbanisation of the surrounding area. This is further exacerbated by areas of fairly steep slopes leading to watercourses which are vulnerable to erosion (Table 1; Figure 5 and Figure 10).

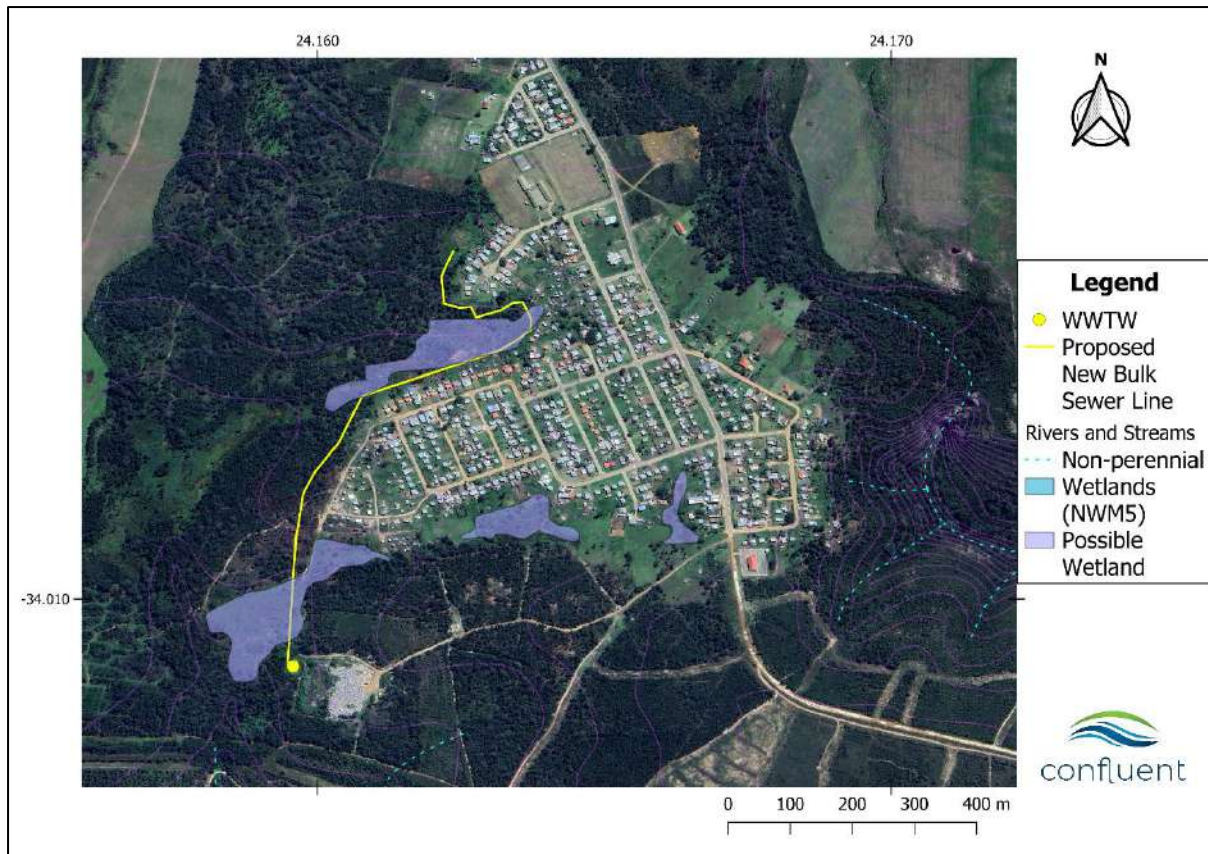
The mapped watercourses along the extent of the proposed sewer line are five non-perennial rivers, two of the rivers are flowing in a southern direction and three flowing in an easterly direction (Figure 10). None of the mapped non-perennial rivers are to be crossed by the new bulk sewer line. All of the non-perennial rivers are mapped to flow into the Groot River approximately 900 m south of the WWTW. The three non-perennial rivers flowing east flow into the Klip River, which joins the Groot River 3.5 km southeast of the WWTW (Figure 1). No wetlands are mapped to occur in the immediate vicinity of the WWTW and associated infrastructure, however, four possible wetlands were identified by the Environmental Assessment Practitioner EAP (Figure 10).

Figure 10: The WWTW and proposed new bulk sewer line (showing Option 2) in relation to mapped watercourses.

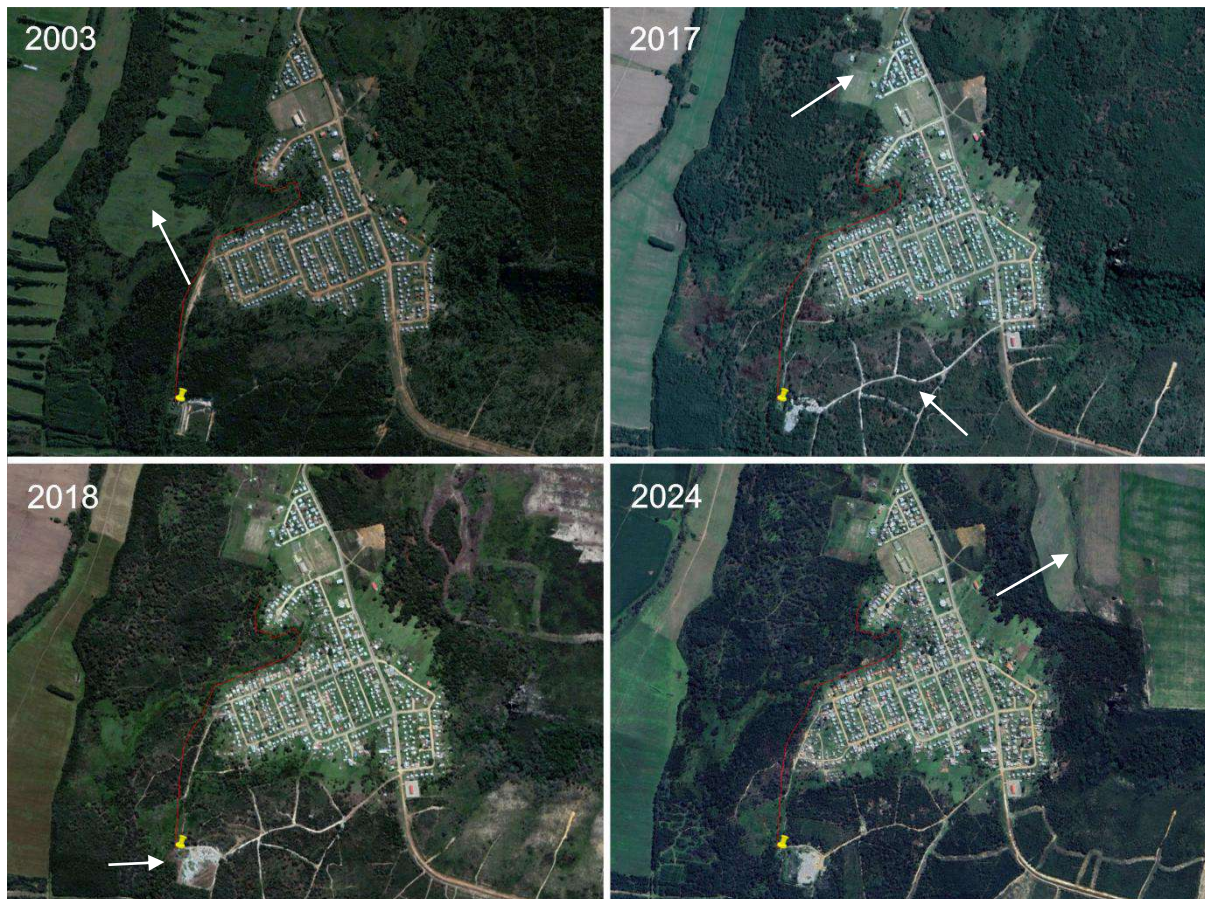
Historically, the environment surrounding the WWTW and sewer infrastructure proposed to be upgraded has undergone minimal noticeable changes in the past 22 years from 2003 to 2025. The surrounding area in the immediate vicinity of the WWTW and sewer infrastructure remained disturbed by the Woodlands settlement throughout the 22 years. Notable changes are listed below and can be seen in Figure 11.

- Extensive vegetation clearing in bushy areas to the west of Woodlands which is observable in 2003, but revegetates during the decades thereafter.
- Significant increase in vehicle tracks between Woodlands and the landfill site between 2003 and 2017.
- Continuous expansion of the landfill site between 2003 and the present.
- Increase in more recent years of informal houses / shacks along the periphery of Woodlands.
- Extensive clearing of vegetation East of Woodlands between 2018 and 2024.

Figure 11. Historical photos showing WWTW and proposed new bulk sewer line's location from 2003 until 2024 (Google Earth imagery). Arrows indicate the location of an impact when it is first observed.

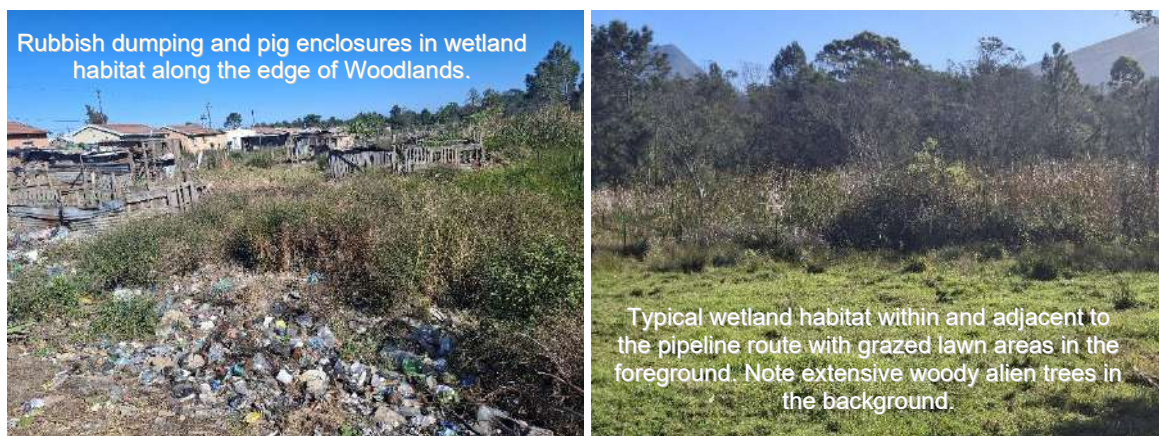
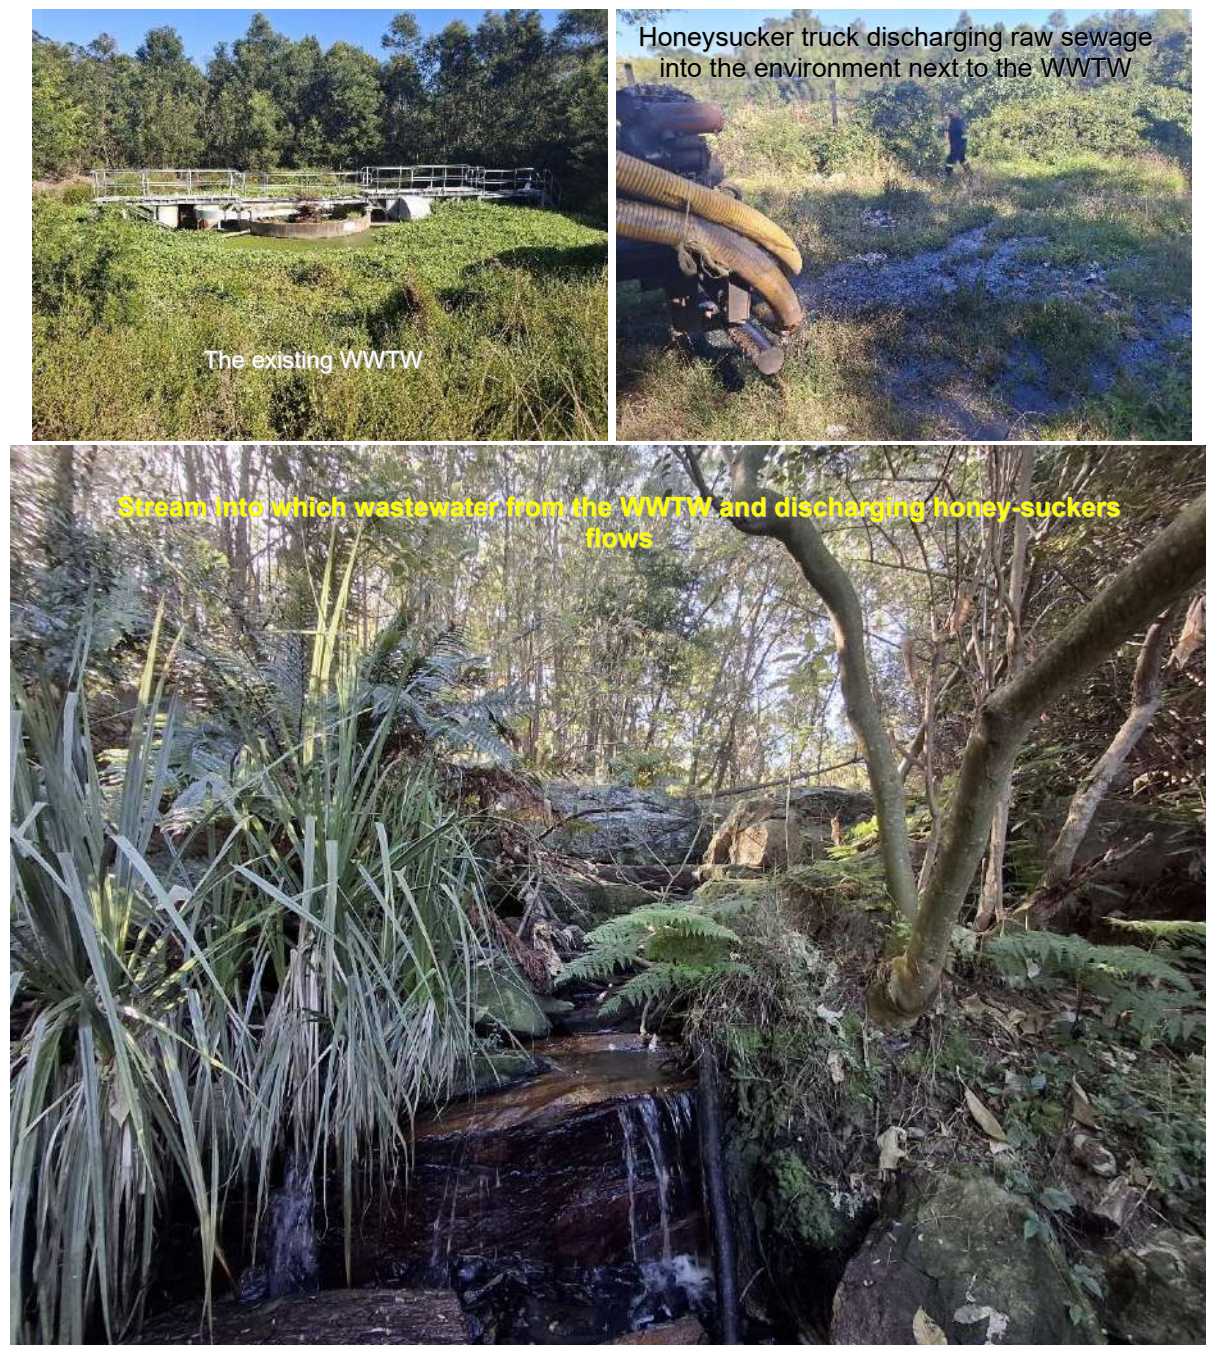
Figure 12. Photos taken of various features during the site visit.

Extensive wetland habitat is present to the west and south of Woodlands in an unconfined (broad) valley bottom. As the gradient steepens to the south, the wetland gives way to a flowing stream with riparian forest (Figure 12). It is this stream that receives the wastewater outflow at present, and the proposed outflow for the upgraded WWTW.

In some parts of Woodlands the residents have created large areas of rubbish dumping approximately 20 – 30m from houses. Dumping areas frequently overlap with wetland habitat which was observed almost continuously along the western boundary of Woodlands. In addition, informal livestock enclosures containing pigs were also constructed adjacent to wetland areas. Free-ranging grazing cattle have created grass lawns adjacent to wetland areas.

The Wastewater Treatment Plant itself is overgrown with vegetation which has covered the area outside as well as inside infrastructure. It was completely non-operational at the time of the site visit. A honey sucker truck contracted by the municipality to collect sewer from parts of Woodlands was directly observed discharging the raw waste down a vegetated slope leading directly to the wetland area (Figure 12). The truck driver cited the WWTW as inoperative and stated that even driving the truck into the plant was a hazard.

The WWTW in its current condition is also considered a safety hazard both for people and animals. The site has open access, and the edge of the old pond is indistinct with overgrown vegetation, while the pond is full of (likely) sludge, water and vegetation. Animals or people could fall into it, and therefore maintenance at the site such as cutting vegetation around the pond and fencing it off should be undertaken as soon as possible.

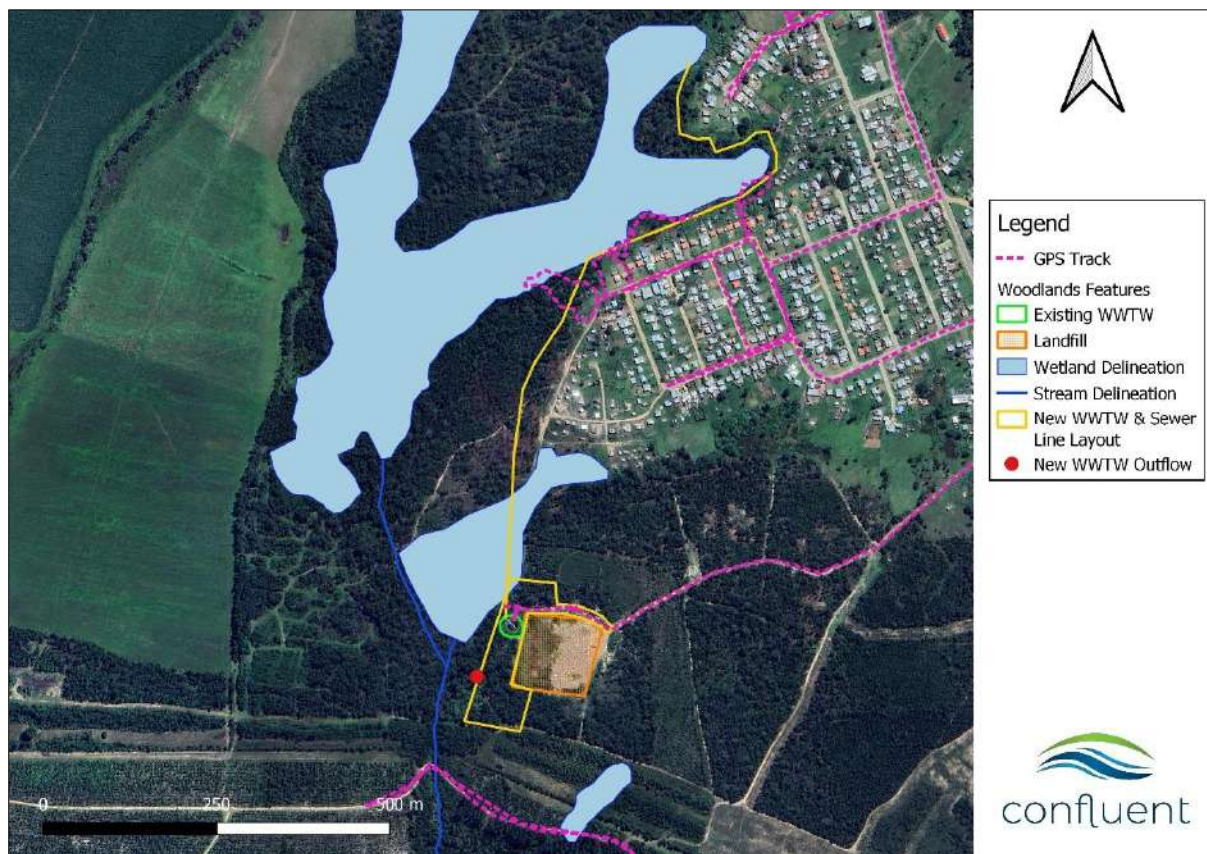
Figure 13. GPS track walked and driven during the site assessment and delineated wetland and stream. Sewer line route shown is Option 2.

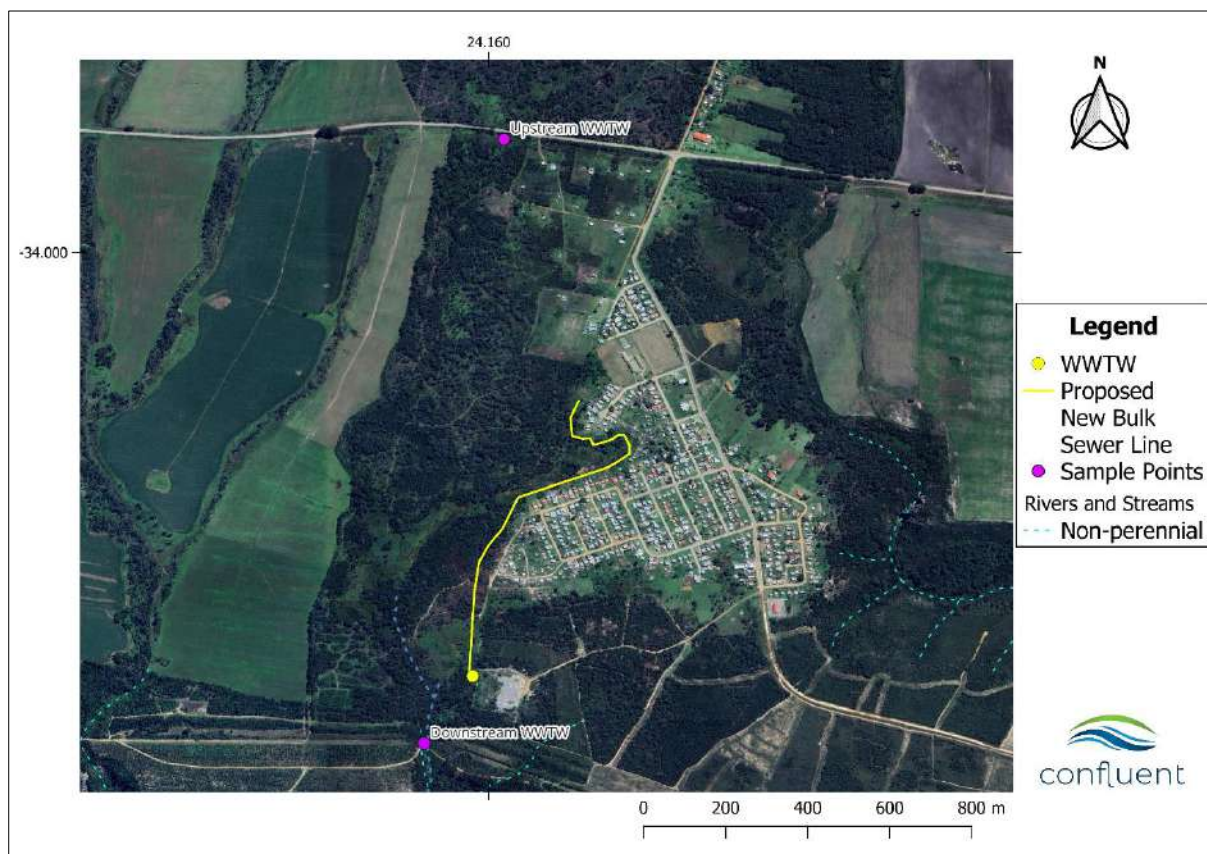
A 1 Litre water sample was collected from the wetland area upstream of Woodlands and a second sample was collected from the stream downstream of the WWTW and discharge point for honey-suckers. The upstream site provides a reference point for the impact associated with the discharge of sewage and current operation (if any) of the WWTW (Figure 14).

Figure 14: Map of the WWTW and proposed new bulk sewer line (Option 2 shown) in relation to water quality sampling points.

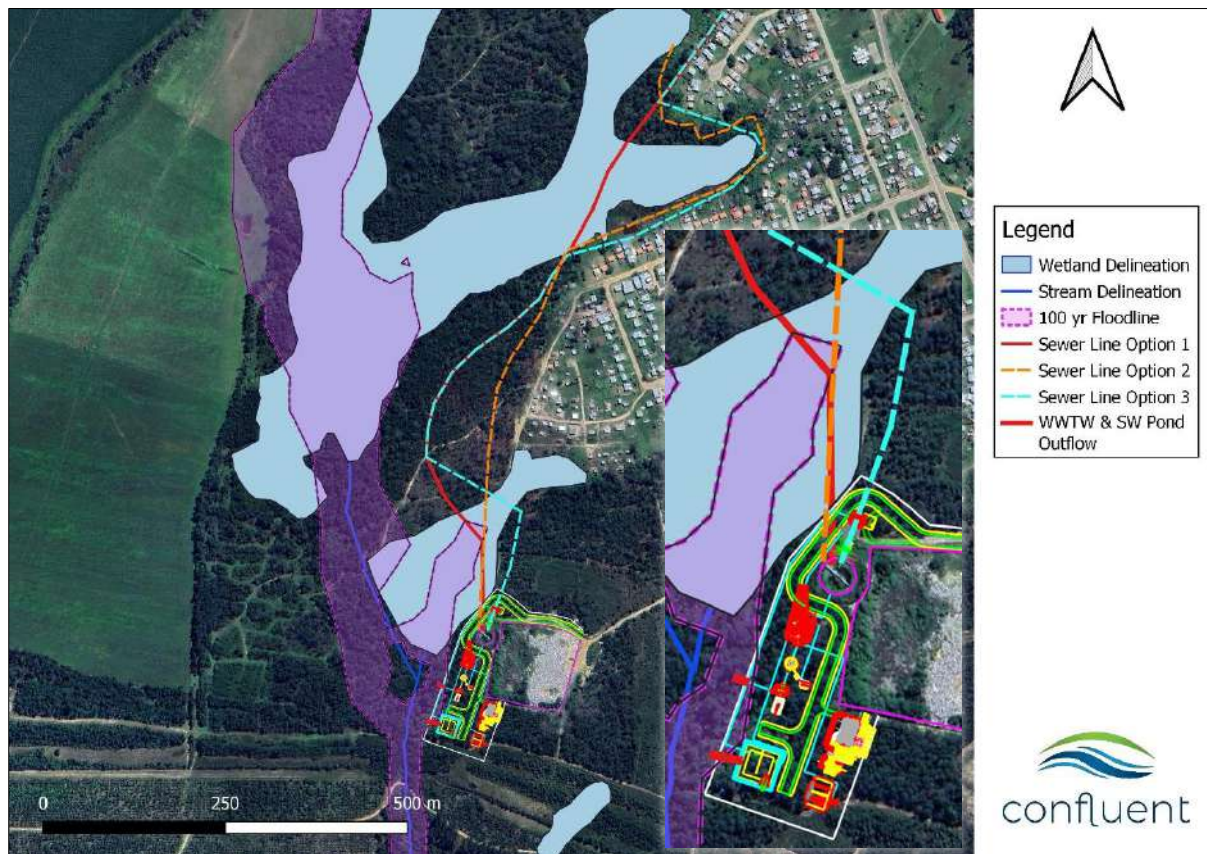
The layout for assessment is shown in as much detail as was provided at the time of writing (Figure 16). The mapped 1:100 year floodline does not appear well aligned with the wetland delineation. In the case of the wetland delineation, this could be due to low confidence in the delineation of the edge given the difficulties of access previously mentioned. However, the areas of delineated wetland were correlated directly with wetland habitat observed in the field and using drone imagery. As unchanneled valley-bottom wetlands, these systems are unlikely to carry high volumes of channelled flows associated with a conventional flood line. If that were the case, then channels would have formed through the wetland, and vegetation would have been washed away in these areas. Rather, it is expected that water would spread out and fully saturate the wetland area; moving downslope mostly in the form of interflow.

Two outlets from the WWTW to the stream along the western boundary are necessary. The first is the discharge of treated wastewater from the chlorine contact tank around mid-way along the western extent of the WWTW (Figure 16). The second overflow structure will be constructed to discharge any overflowing stormwater from the stormwater pond to the drainage line (southwest corner of the WWTW; Figure 16). This would only be necessary during flooding conditions because under ordinary circumstances the stormwater overflow captured in the stormwater pond would be recirculated back to the WWTW head of works. No detailed designs for these outlets were provided at the time of writing, but mitigation measures to minimise impacts on the watercourse through all phases of development are still provided here, and were discussed with the engineers.

Figure 16. Layout of the proposed WWTW and pipeline options in relation to delineated watercourses and the 1:100 year floodline (determined by SMEC). Inset shows enlargement of the WWTW area for greater visibility of the two outlets proposed to the watercourse.

- Design of the WWTW has allowed for additional flows due to stormwater ingress during high rainfall events. Stormwater will be diverted to the stormwater pond southwest of the site from where it will be recirculated to the head of works for treatment. The stormwater pond is supported and recommended to mitigate the impact of stormwater ingress.
- In case of very high inflows of stormwater, an emergency overflow from the stormwater pond must be constructed in such a way the water is delivered to the watercourse downslope without causing erosion to the slope, stream banks, or stream bed. A stepped gabion structure with stilling basin is recommended.
- The outflow of treated wastewater must be constructed to ensure flows (anticipated at 0.6-1m/s) will not cause erosion of the slope, stream bank or stream bed into

- which it flows. Like the above a stepped gabion structure with stilling basin is recommended.
- Outlets into the stream from the chlorine contact tank and the stormwater pond should not have a perpendicular entry to the stream that could cause erosion on the opposite bank.

- The design should include bund walls around the biological reactor.
- A pipeline should be installed between the outlet of the chlorine contact tank and the stormwater pond. This should be an emergency outlet that could utilise the storage provided by the stormwater pond on a temporary basis and to recirculate the sewage for treatment in the event of equipment failure in the WWTW. This would only function if capacity in the stormwater pond was available and would reduce or prevent serious pollution of the watercourse due to the discharge of partially treated or untreated sewage (in the event of an equipment failure).

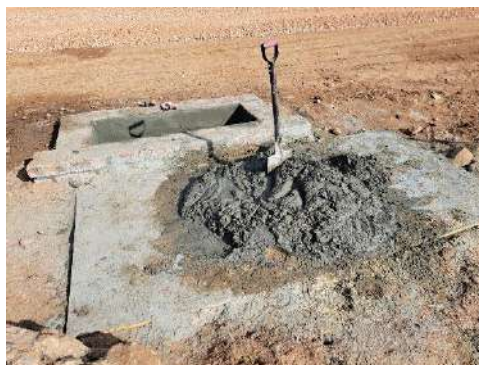
- Concrete mixing (dagha) should be done on boards, trays or strong plastic sheeting, away from the watercourse (Figure 17) as cement is a pollutant that must not be allowed to flow into the watercourse. Any waste cement should be allowed to dry and be disposed of in skips at the site. No waste cement should be discarded in aquatic habitats under any circumstance.

Figure 17. Example of mixing cement (dagha) on a wooden board to prevent wash off to watercourses during rainfall.

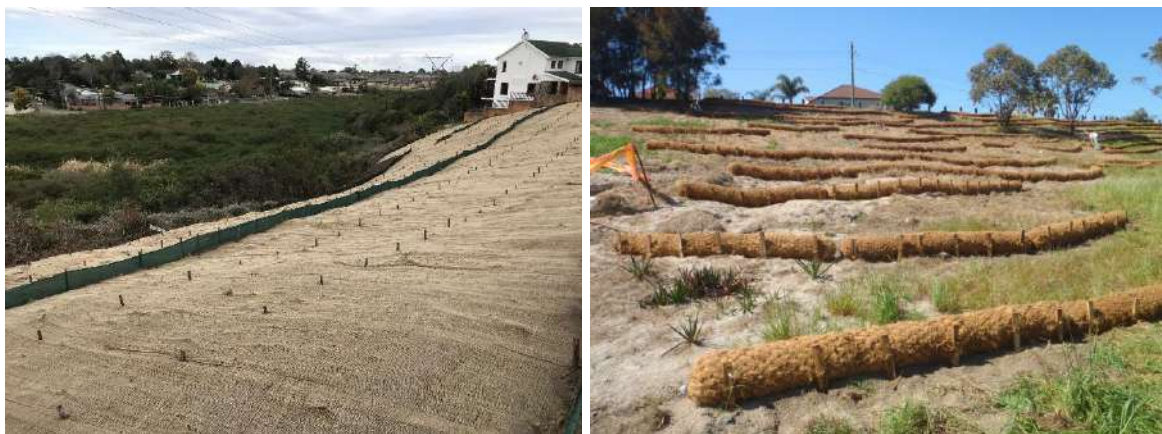
- Reduce transport of sediment down slopes through use of structures such as silt fences, biodegradable coir logs and soilsaver biodegradable matting (Figure 18).

Figure 18. Examples of silt fences with soil saver matting (left) and coir logs (right) used to trap sediment mobilised from steep slopes during the construction phase.

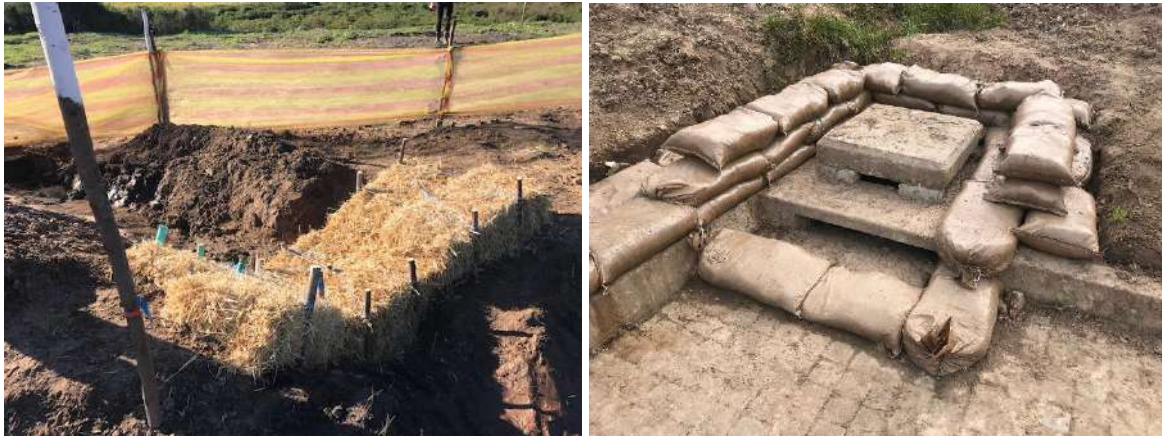
- Construct haybale check dams within concentrated flow paths to encourage water pooling and seepage through the haybale, while sediment remains in drains (Figure 19).
- Protect stormwater drains which lead to aquatic habitats with sandbags to prevent silt-laden water from entering drains (Figure 19).

Figure 19. Examples of a haybale check dam in a concentrated flow path (left) and sandbags surrounding a stormwater drain which leads to a wetland. This prevents silt laden water from entering the wetland where it would be difficult to remove.
