# Proposed Upgrade of Sewerage Infrastructure in Woodlands, Eastern Cape.

## Aquatic Biodiversity Impact Assessment

**Prepared For:** Blue Pebble (Pty) Ltd  
**Author:** Jackie Dabrowski (PhD)  
Confluent Environmental Pty (Ltd)  
7 St. Johns Street,  
Dormehls Drift,  
George, 6529  
**Report Ref:** CENV10  
**SACNASP:** Pr. Sci. Nat. (Aquatic & Ecological  
Science – 115166)  
**Date:** July 2025  
**Version:** Draft

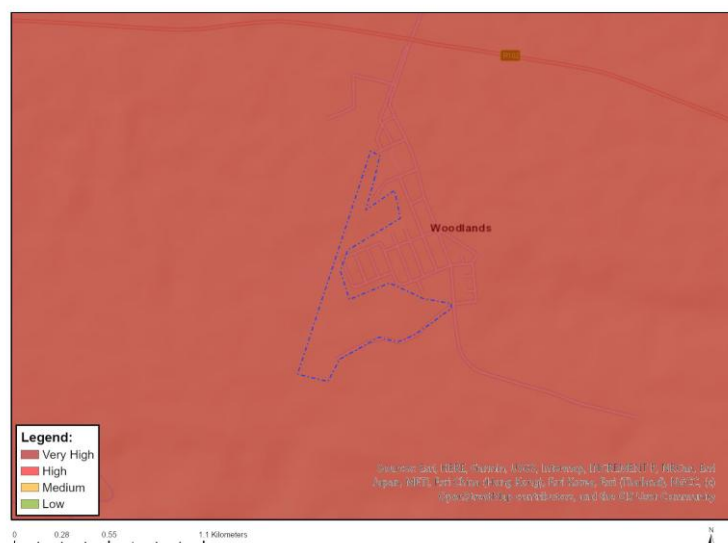
Figure 2: Results of the DFFE Screening Tool which indicate Very High Sensitivity of the Aquatic Biodiversity theme for the preferred development pipeline.

According to the DFFE screening tool, aquatic biodiversity at the site has a **Very High** sensitivity (Figure 2). The sensitivity features that triggered this classification are:

- Ecological Support Area 1 (ESA 1)
- Strategic Water Source Area (SWSA) for surface water in the Tsitsikamma

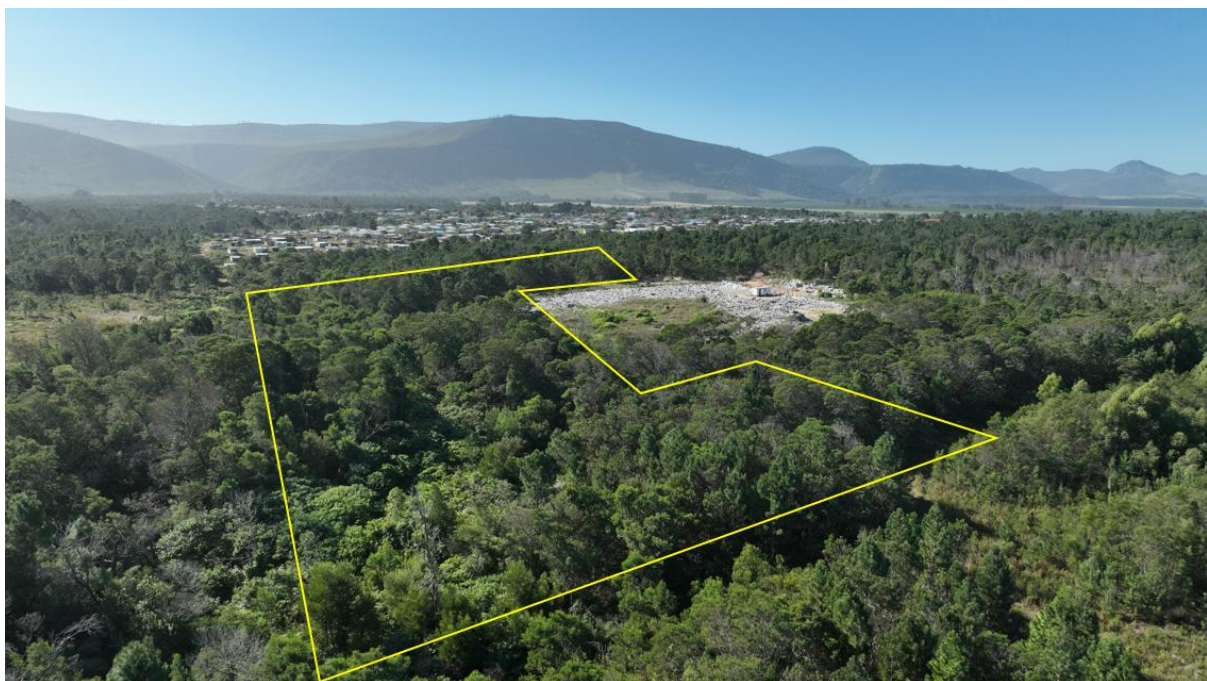
Figure 4. Approximate area of the new WWTW footprint adjacent to the existing landfill site in Woodlands.

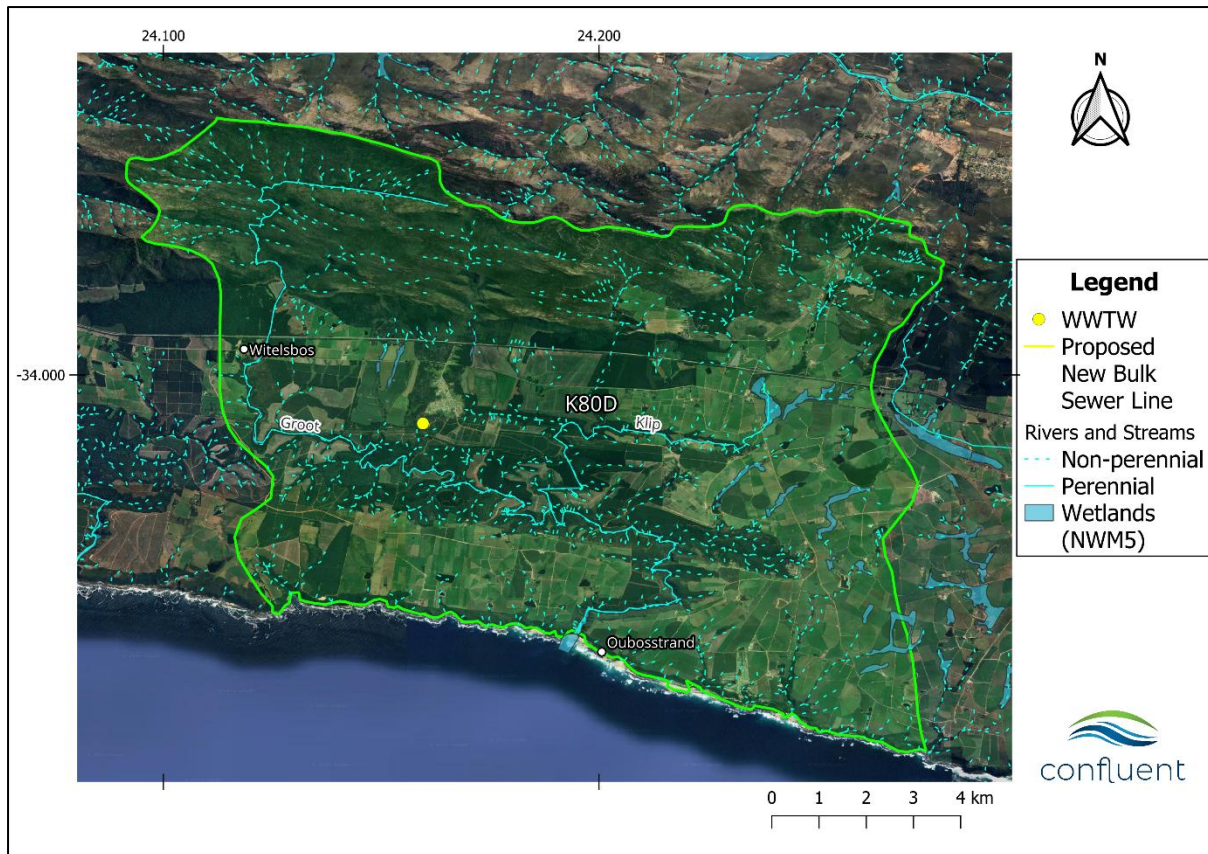
Figure 5. Location of the WWTW and proposed new bulk sewer line in the quaternary catchment K80D.

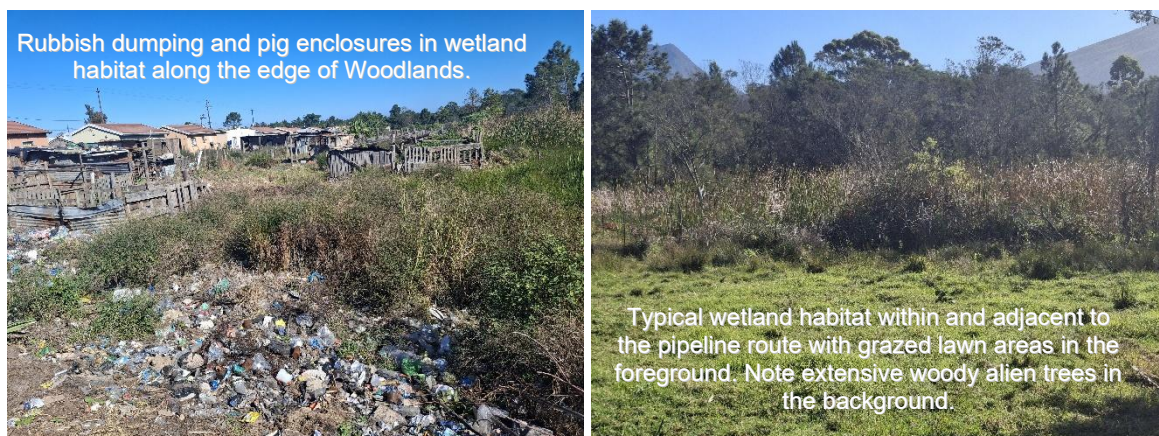
*Figure 12. Photos taken of various features during the site visit.*

The following series of photos illustrate key points regarding the present condition and impacts affecting the pipeline route and WWTW site (Figure 12).

Extensive wetland habitat is present to the west and south of Woodlands in an unconfined (broad) valley bottom. As the gradient steepens to the south, the wetland gives way to a flowing stream with riparian forest (Figure 12). It is this stream that receives the wastewater outflow at present, and the proposed outflow for the upgraded WWTW.

In some parts of Woodlands the residents have created large areas of rubbish dumping approximately 20 – 30m from houses. Dumping areas frequently overlap with wetland habitat which was observed almost continuously along the western boundary of Woodlands. In addition, informal livestock enclosures containing pigs were also constructed adjacent to wetland areas. Free-ranging grazing cattle have created grass lawns adjacent to wetland areas.

The Wastewater Treatment Plant itself is overgrown with vegetation which has covered the area outside as well as inside infrastructure. It was completely non-operational at the time of the site visit. A honey sucker truck contracted by the municipality to collect sewer from parts of Woodlands was directly observed discharging the raw waste down a vegetated slope leading directly to the wetland area (Figure 12). The truck driver cited the WWTW as inoperative and stated that even driving the truck into the plant was a hazard.

The WWTW in its current condition is also considered a safety hazard both for people and animals. The site has open access, and the edge of the old pond is indistinct with overgrown vegetation, while the pond is full of (likely) sludge, water and vegetation. Animals or people could fall into it, and therefore maintenance at the site such as cutting vegetation around the pond and fencing it off should be undertaken as soon as possible.

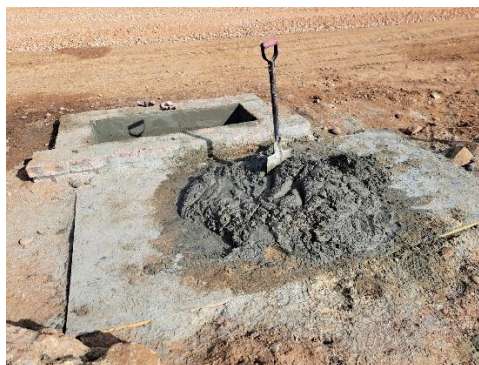
Figure 17. Example of mixing cement (dagha) on a wooden board to prevent wash off to watercourses during rainfall.

- Concrete mixing (dagha) should be done on boards, trays or strong plastic sheeting, away from the watercourse (Figure 17) as cement is a pollutant that must not be allowed to flow into the watercourse. Any waste cement should be allowed to dry and be disposed of in skips at the site. No waste cement should be discarded in aquatic habitats under any circumstance.

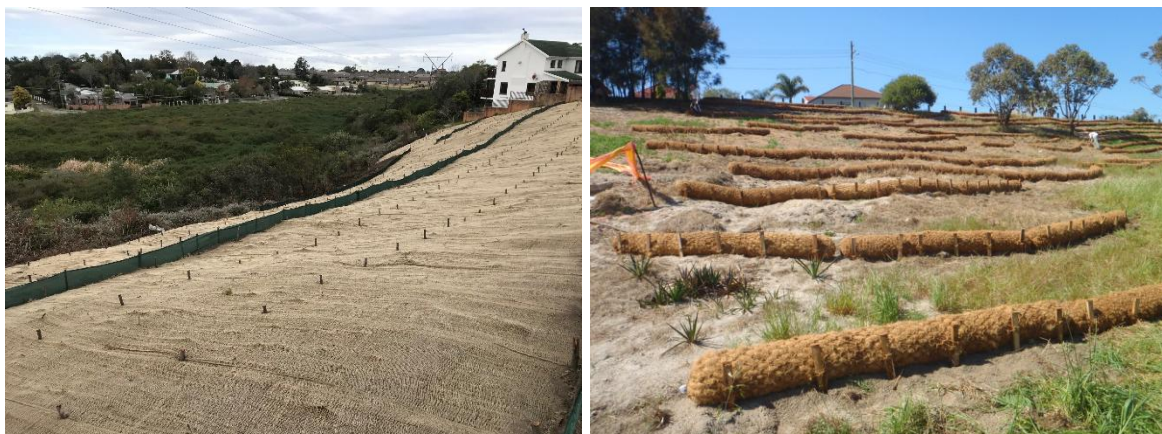
Figure 18. Examples of silt fences with soil saver matting (left) and coir logs (right) used to trap sediment mobilised from steep slopes during the construction phase.

- Reduce transport of sediment down slopes through use of structures such as silt fences, biodegradable coir logs and soilsaver biodegradable matting (Figure 18).

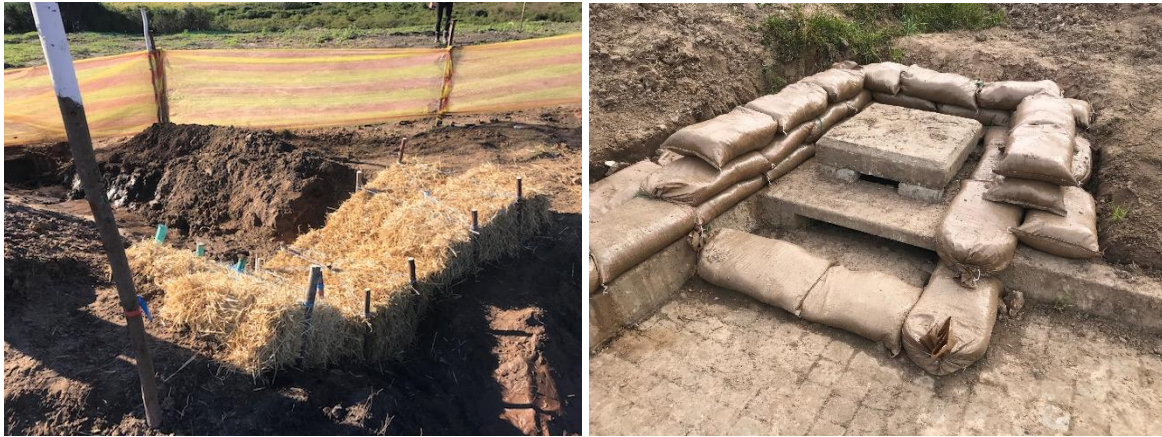
Figure 19. Examples of a haybale check dam in a concentrated flow path (left) and sandbags surrounding a stormwater drain which leads to a wetland. This prevents silt laden water from entering the wetland where it would be difficult to remove.

- Construct haybale check dams within concentrated flow paths to encourage water pooling and seepage through the haybale, while sediment remains in drains (Figure 19).
- Protect stormwater drains which lead to aquatic habitats with sandbags to prevent silt-laden water from entering drains (Figure 19).
