# Proposed Upgrade of Sewerage Infrastructure in Woodlands, Eastern Cape.

## Aquatic Biodiversity Impact Assessment

**Prepared For:** Blue Pebble (Pty) Ltd  
**Author:** Jackie Dabrowski (PhD)  
Confluent Environmental Pty (Ltd)  
7 St. Johns Street,  
Dormehls Drift,  
George, 6529  
**Report Ref:** CENV10  
**SACNASP:** Pr. Sci. Nat. (Aquatic & Ecological  
Science – 115166)  
**Date:** July 2025  
**Version:** Draft

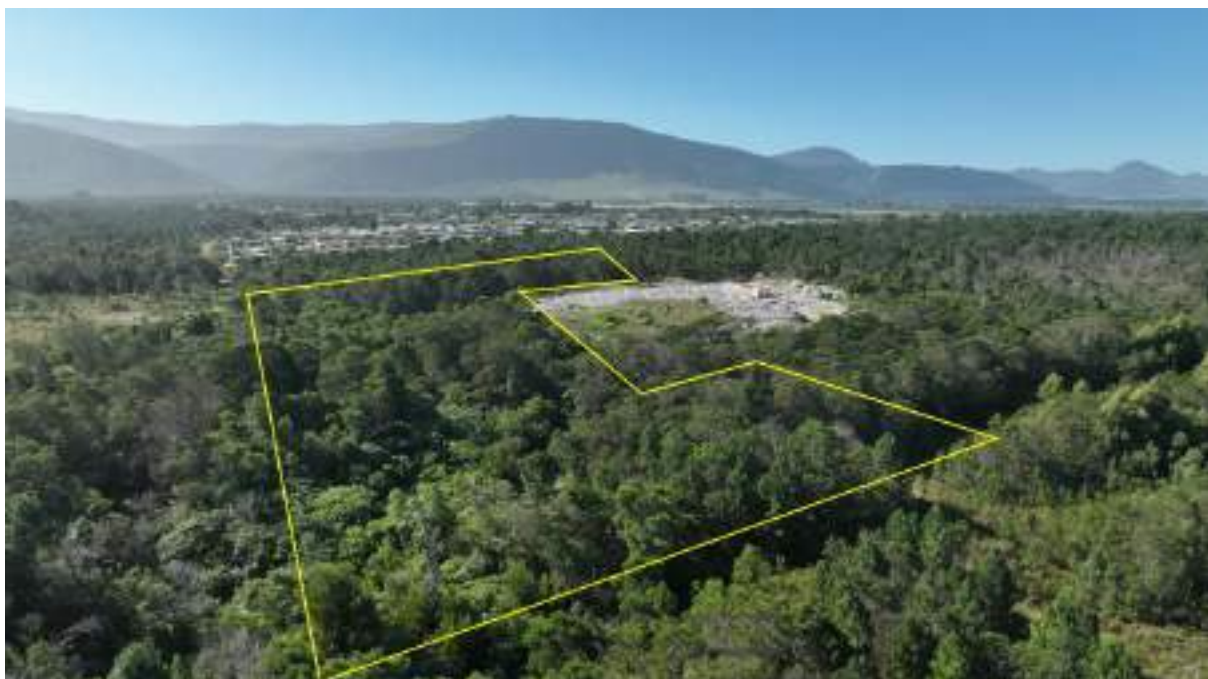
Figure 4. Approximate area of the new WWTW footprint adjacent to the existing landfill site in Woodlands.

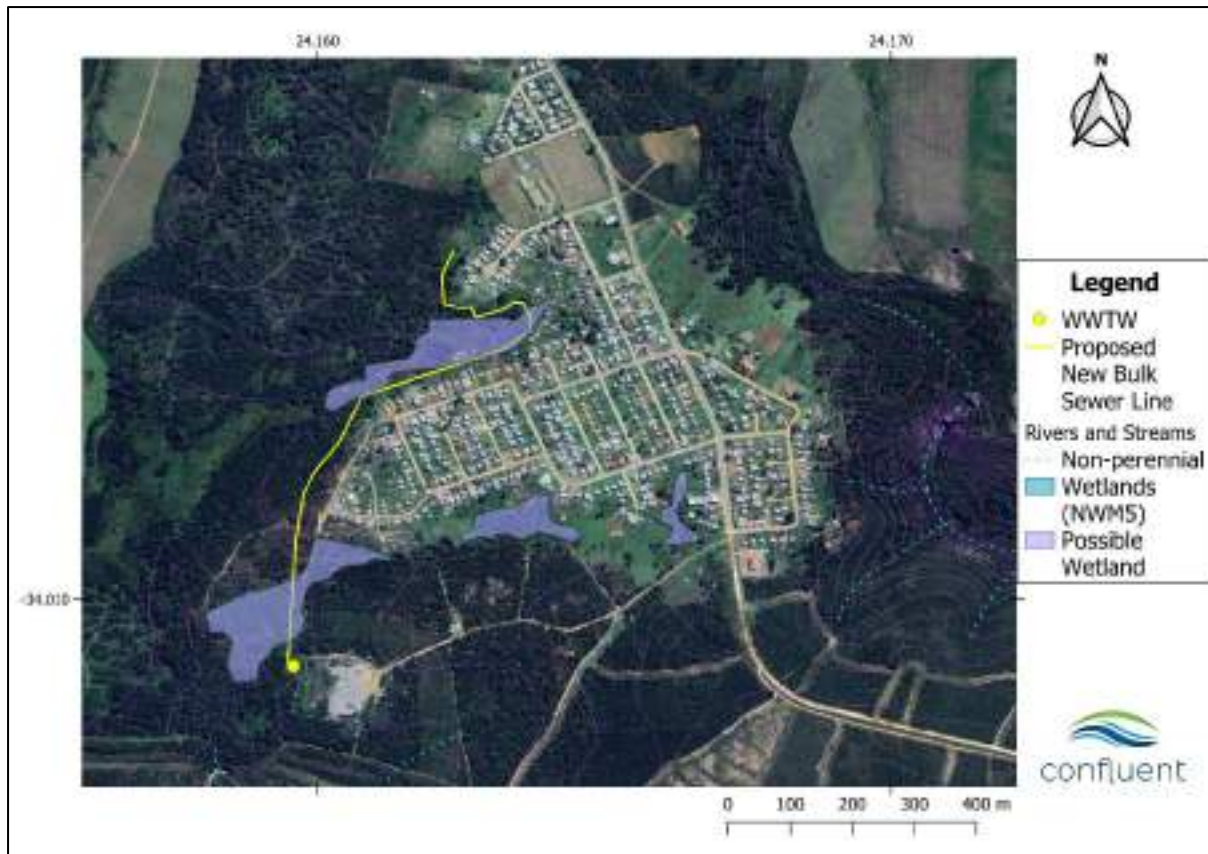
The mapped watercourses along the extent of the proposed sewer line are five non-perennial rivers, two of the rivers are flowing in a southern direction and three flowing in an easterly direction (Figure 10). None of the mapped non-perennial rivers are to be crossed by the new bulk sewer line. All of the non-perennial rivers are mapped to flow into the Groot River approximately 900 m south of the WWTW. The three non-perennial rivers flowing east flow into the Klip River, which joins the Groot River 3.5 km southeast of the WWTW (Figure 1). No wetlands are mapped to occur in the immediate vicinity of the WWTW and associated infrastructure, however, four possible wetlands were identified by the Environmental Assessment Practitioner EAP (Figure 10).

Figure 10: The WWTW and proposed new bulk sewer line (showing Option 2) in relation to mapped watercourses.

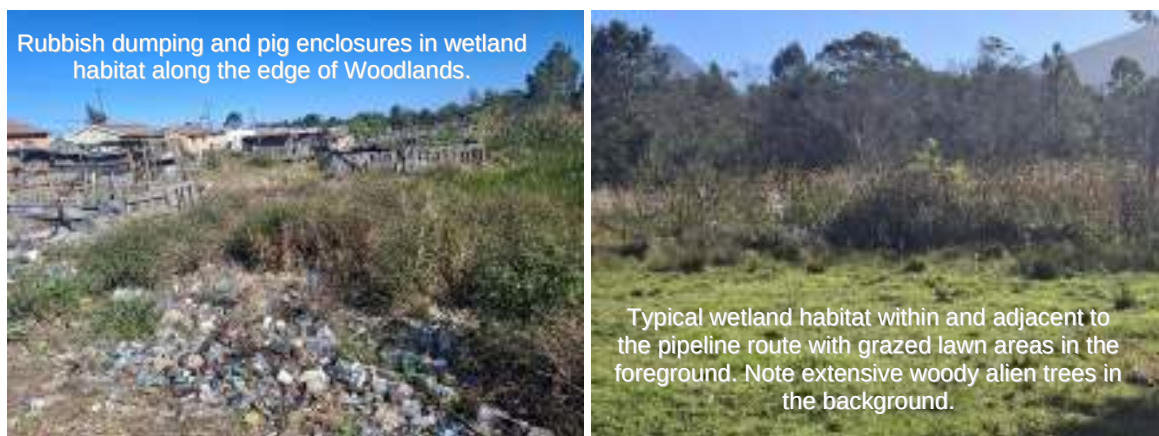
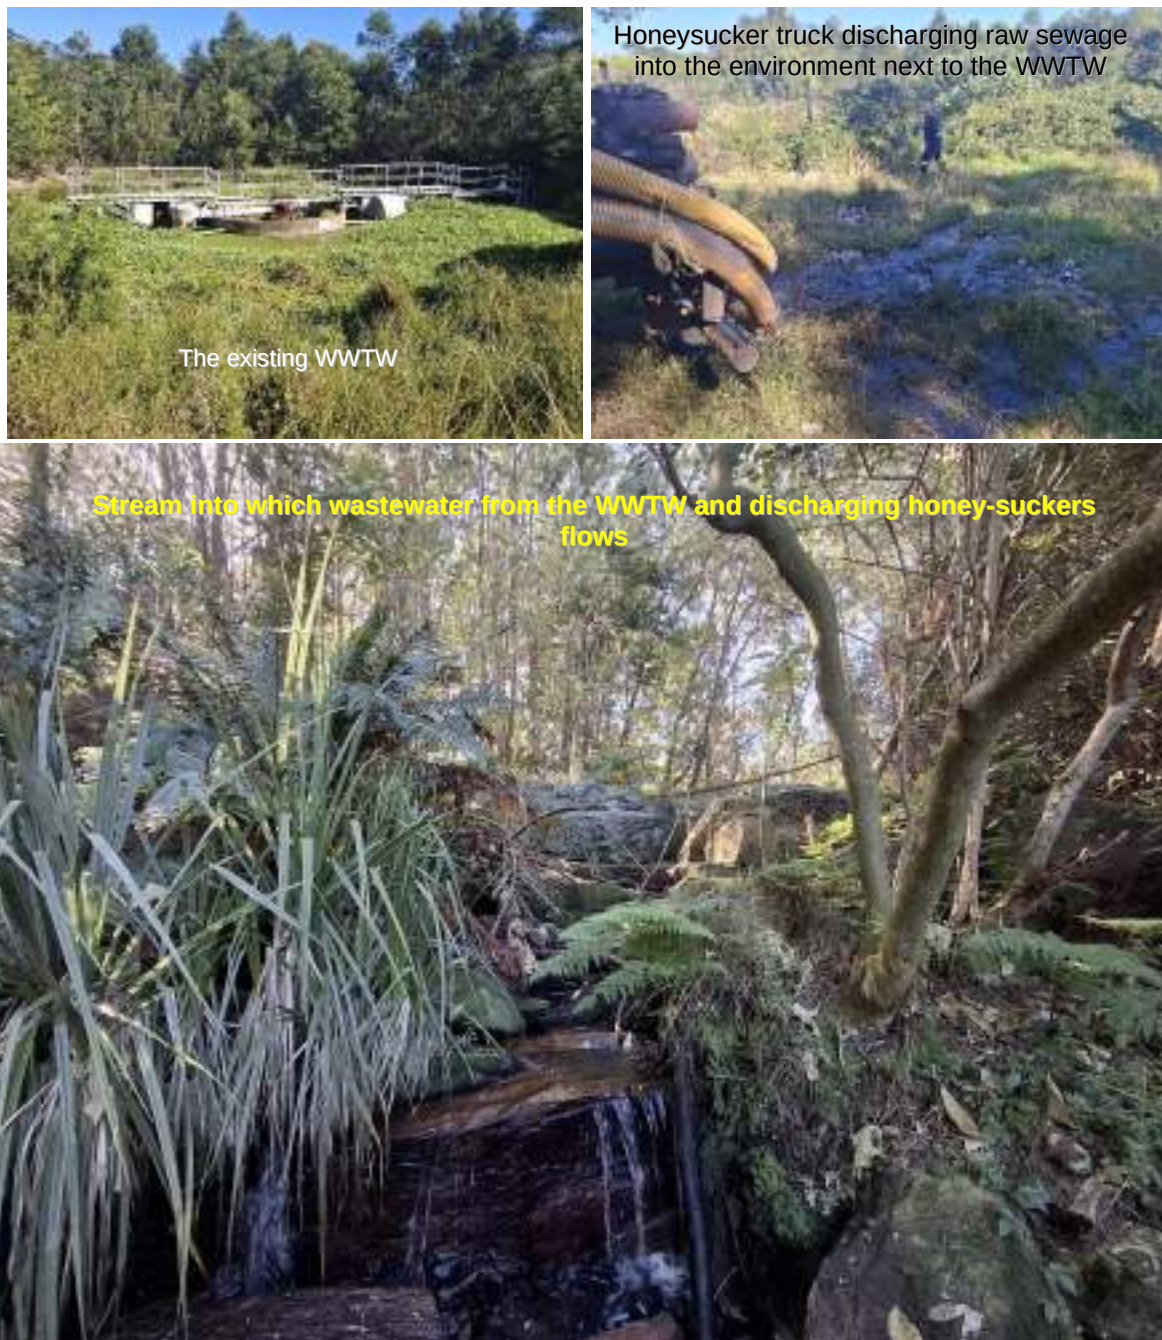
Figure 12. Photos taken of various features during the site visit.

Extensive wetland habitat is present to the west and south of Woodlands in an unconfined (broad) valley bottom. As the gradient steepens to the south, the wetland gives way to a flowing stream with riparian forest (Figure 12). It is this stream that receives the wastewater outflow at present, and the proposed outflow for the upgraded WWTW.

In some parts of Woodlands the residents have created large areas of rubbish dumping approximately 20 – 30m from houses. Dumping areas frequently overlap with wetland habitat which was observed almost continuously along the western boundary of Woodlands. In addition, informal livestock enclosures containing pigs were also constructed adjacent to wetland areas. Free-ranging grazing cattle have created grass lawns adjacent to wetland areas.

The Wastewater Treatment Plant itself is overgrown with vegetation which has covered the area outside as well as inside infrastructure. It was completely non-operational at the time of the site visit. A honey sucker truck contracted by the municipality to collect sewer from parts of Woodlands was directly observed discharging the raw waste down a vegetated slope leading directly to the wetland area (Figure 12). The truck driver cited the WWTW as inoperative and stated that even driving the truck into the plant was a hazard.

Environmental impacts occurring in and around Woodlands are largely related to poor service delivery. During the site visit, several residents expressed frustration and disappointment in the condition of their local environment. Therefore, the proposal to upgrade bulk sewerage infrastructure is fully supported.

The WWTW in its current condition is also considered a safety hazard both for people and animals. The site has open access, and the edge of the old pond is indistinct with overgrown vegetation, while the pond is full of (likely) sludge, water and vegetation. Animals or people could fall into it, and therefore maintenance at the site such as cutting vegetation around the pond and fencing it off should be undertaken as soon as possible.

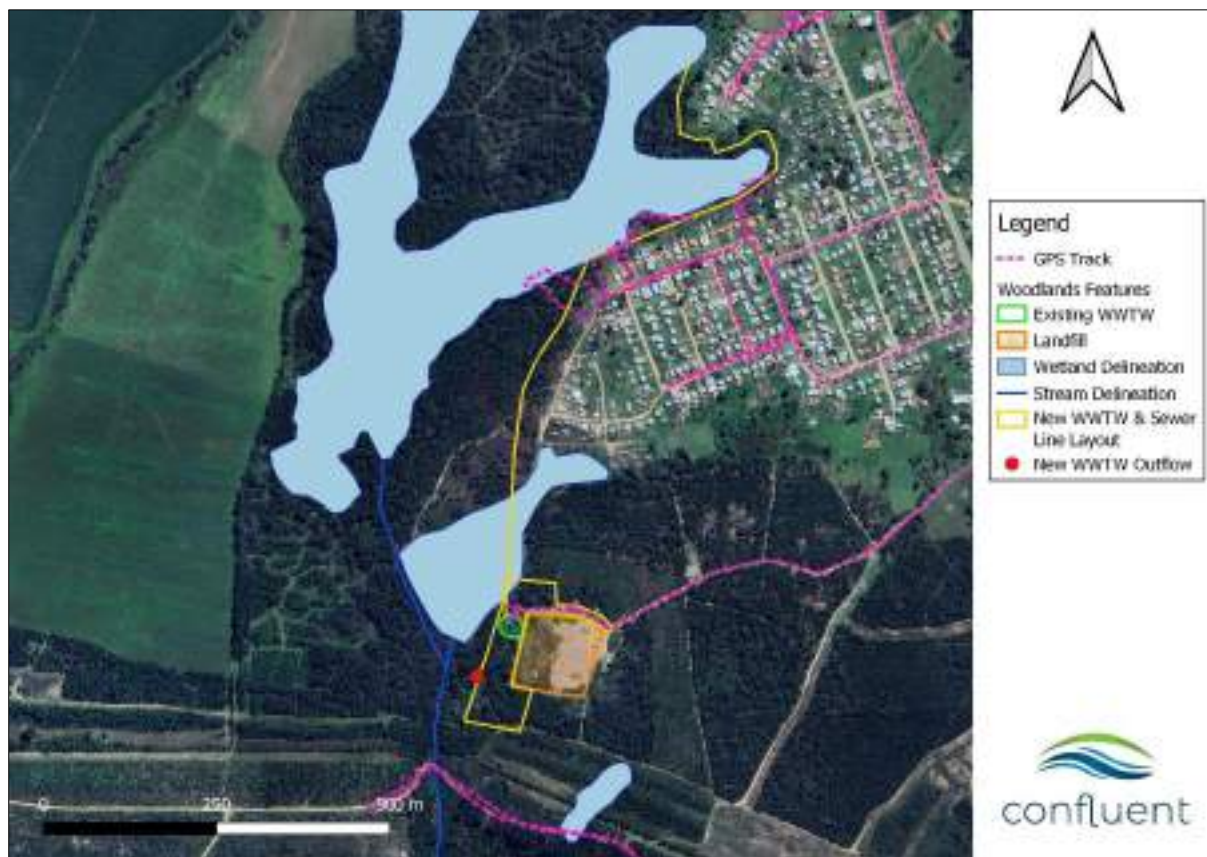
Figure 13. GPS track walked and driven during the site assessment and delineated wetland and stream. Sewer line route shown is Option 2.

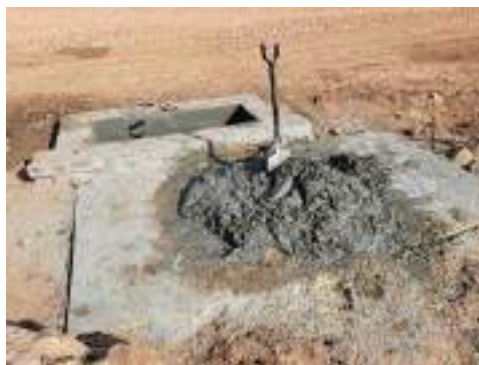
- Concrete mixing (dagha) should be done on boards, trays or strong plastic sheeting, away from the watercourse (Figure 17) as cement is a pollutant that must not be allowed to flow into the watercourse. Any waste cement should be allowed to dry and be disposed of in skips at the site. No waste cement should be discarded in aquatic habitats under any circumstance.

Figure 17. Example of mixing cement (dagha) on a wooden board to prevent wash off to watercourses during rainfall.

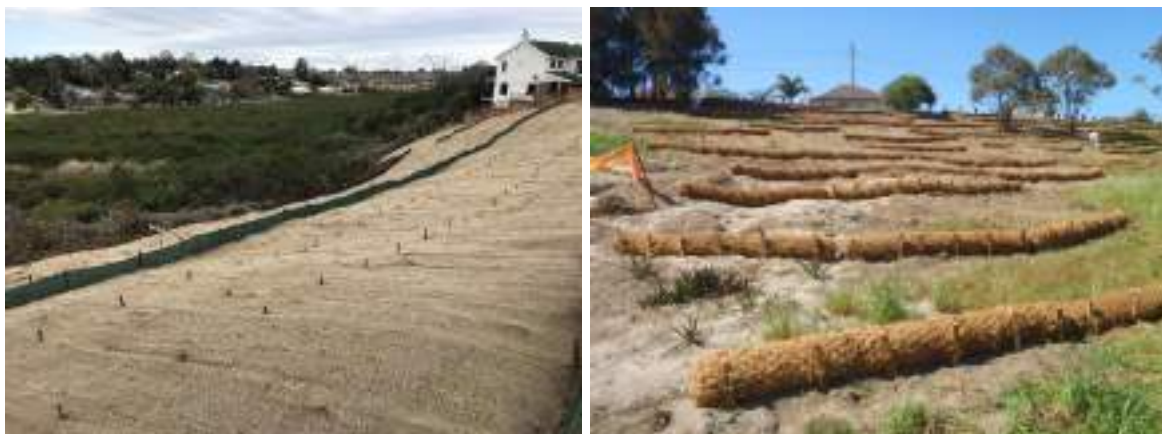
- Reduce transport of sediment down slopes through use of structures such as silt fences, biodegradable coir logs and soilsaver biodegradable matting (Figure 18).

Figure 18. Examples of silt fences with soil saver matting (left) and coir logs (right) used to trap sediment mobilised from steep slopes during the construction phase.

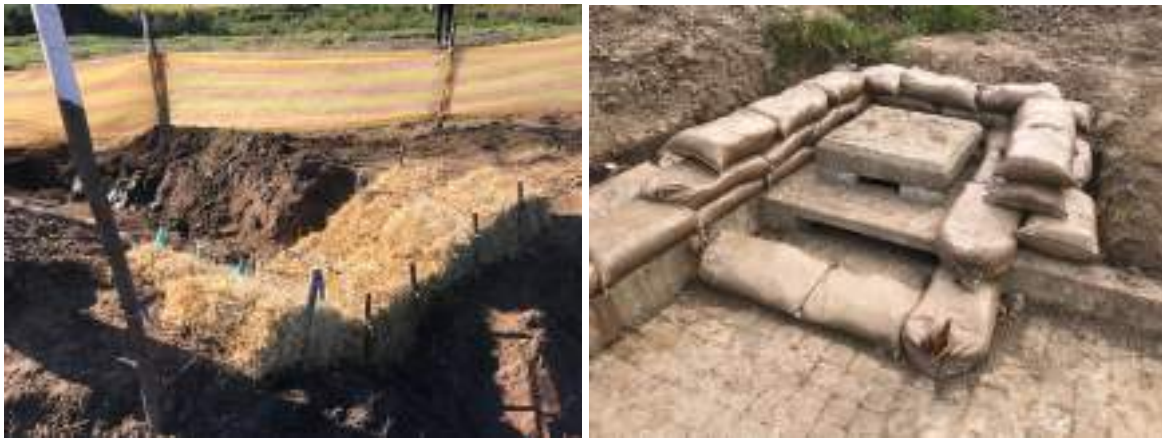
- Construct haybale check dams within concentrated flow paths to encourage water pooling and seepage through the haybale, while sediment remains in drains (Figure 19).
- Protect stormwater drains which lead to aquatic habitats with sandbags to prevent silt-laden water from entering drains (Figure 19).

Figure 19. Examples of a haybale check dam in a concentrated flow path (left) and sandbags surrounding a stormwater drain which leads to a wetland. This prevents silt laden water from entering the wetland where it would be difficult to remove.
